SSC-320

**A STUDY OF EXTREME WAVES AND THEIR
EFFECTS ON SHIP STRUCTURE**

SHIP STRUCTURE COMMITTEE

1983

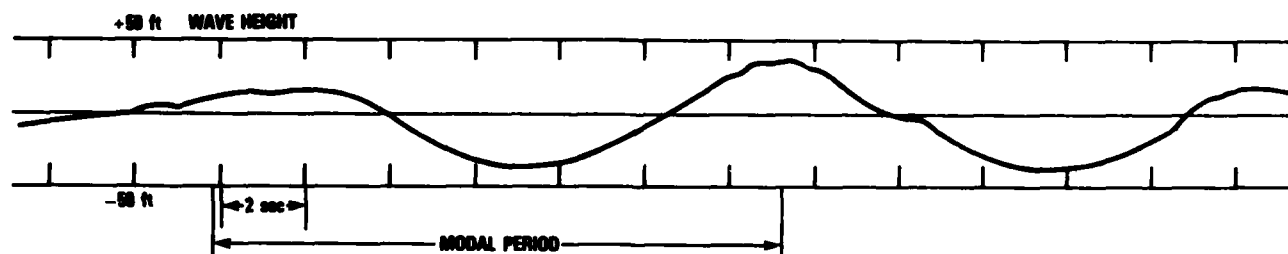
Figure 9a - Episodic Wave: 1155 Hours

Figure 9b - Episodic Wave: 1222 Hours

Figure 9 - Episodic Waves Recorded During Hurricane Camille

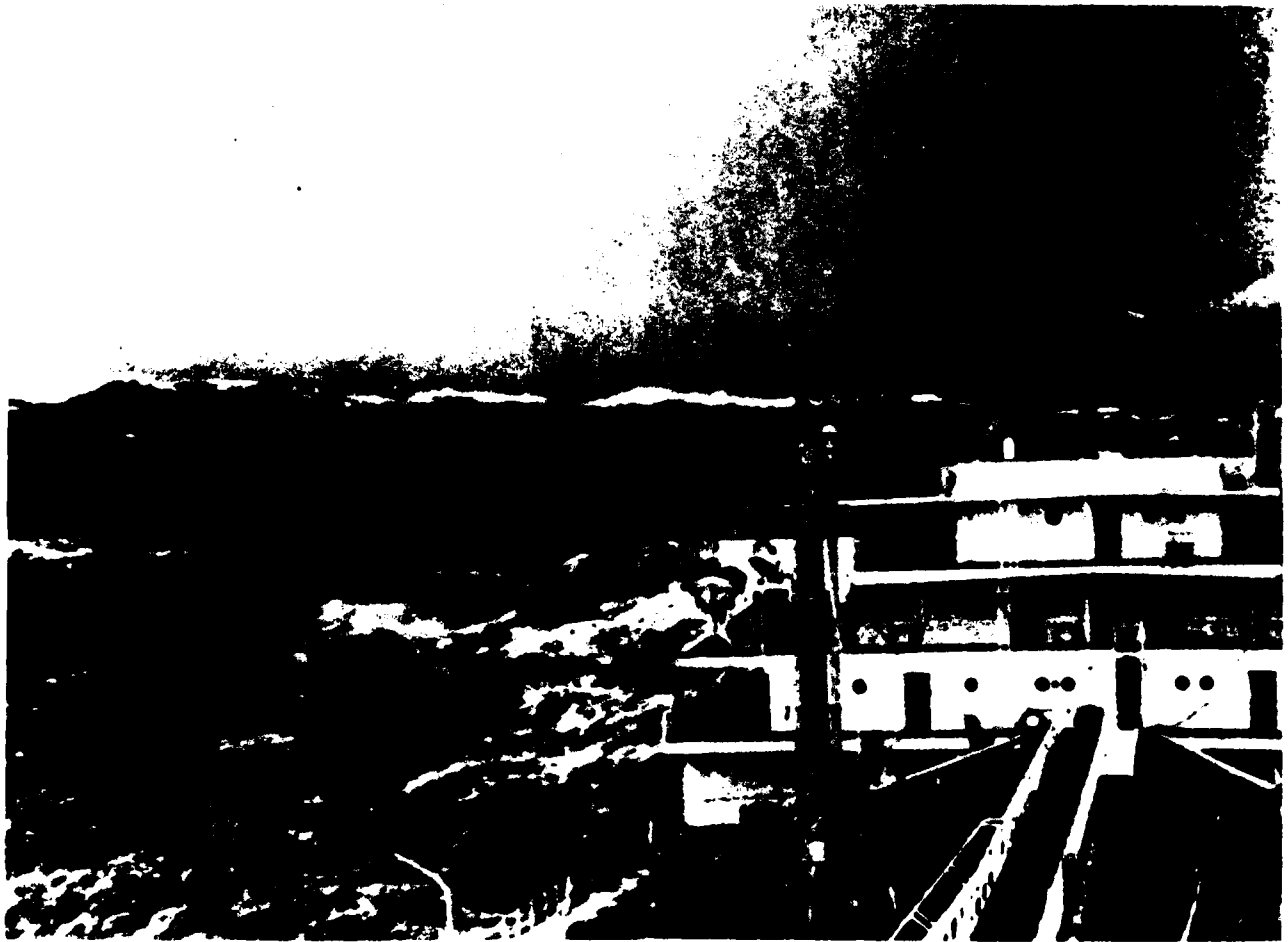
Figure 13 - Steep Long-Crested Wave as Seen from Unidentified Ship
(Photo from Surveyor, May 1968, pg. 23)

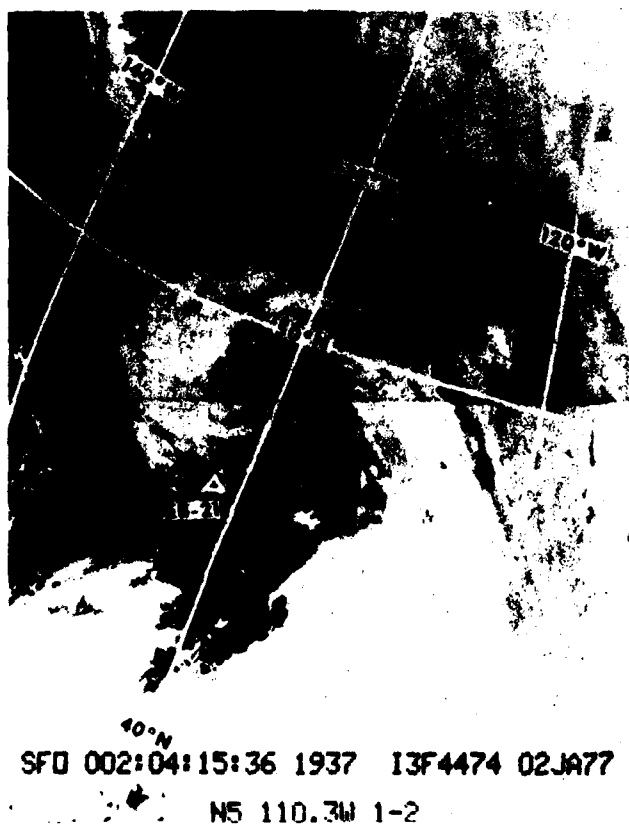
1. Last report from buoy at 1200 GMT on 2 January 1977.
2. From Figures 4 and 6 of Reference 10.

Figure 23 - Cloud Pattern Associated with Capsizing of NOAA Data Buoy
in North Pacific Ocean
